**Remediating and Monitoring  
White Phosphorus Contamination  
at Eagle River Flats  
(Operable Unit C),  
Fort Richardson, Alaska**

**FY 99 Report**

**July 2000**

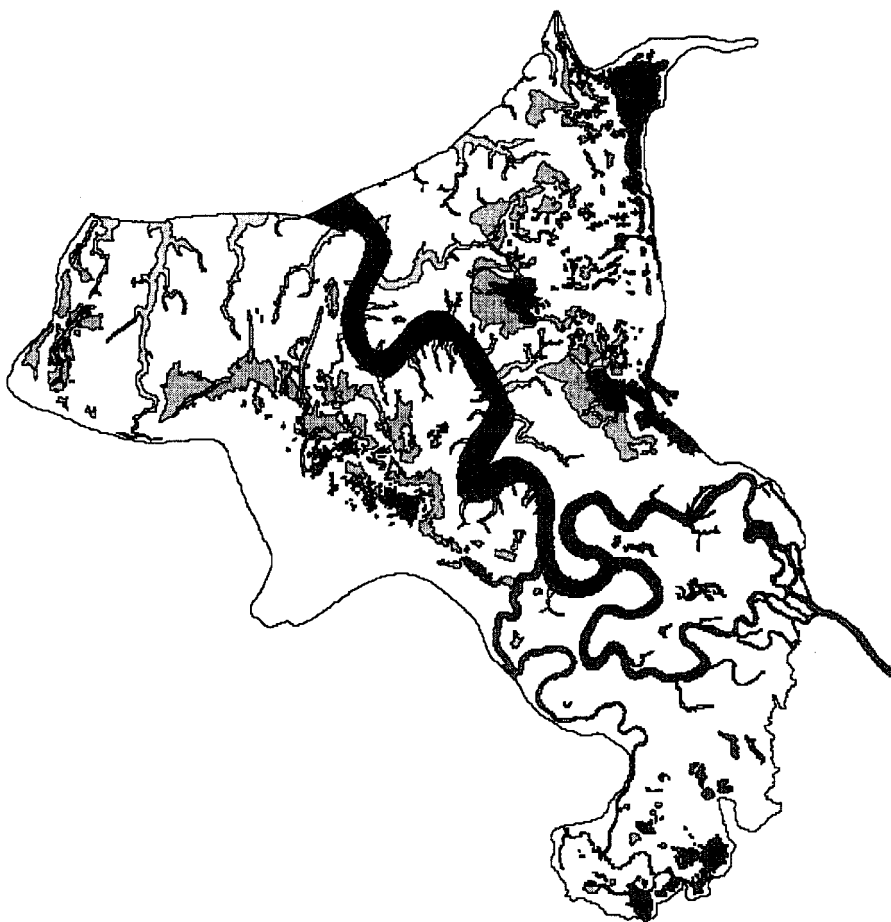
Figure II-2-1. Geographic information system map depicting Eagle River Flats.

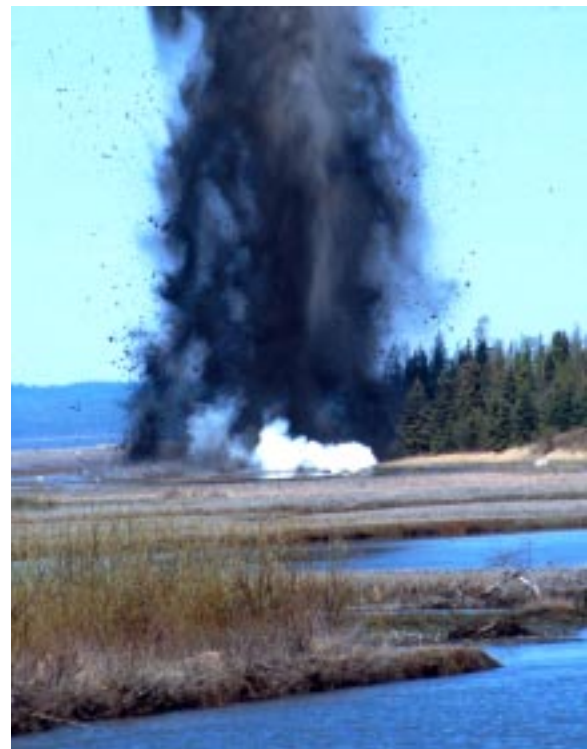
Figure III-1-2. Blasting of sump for Pond 146.

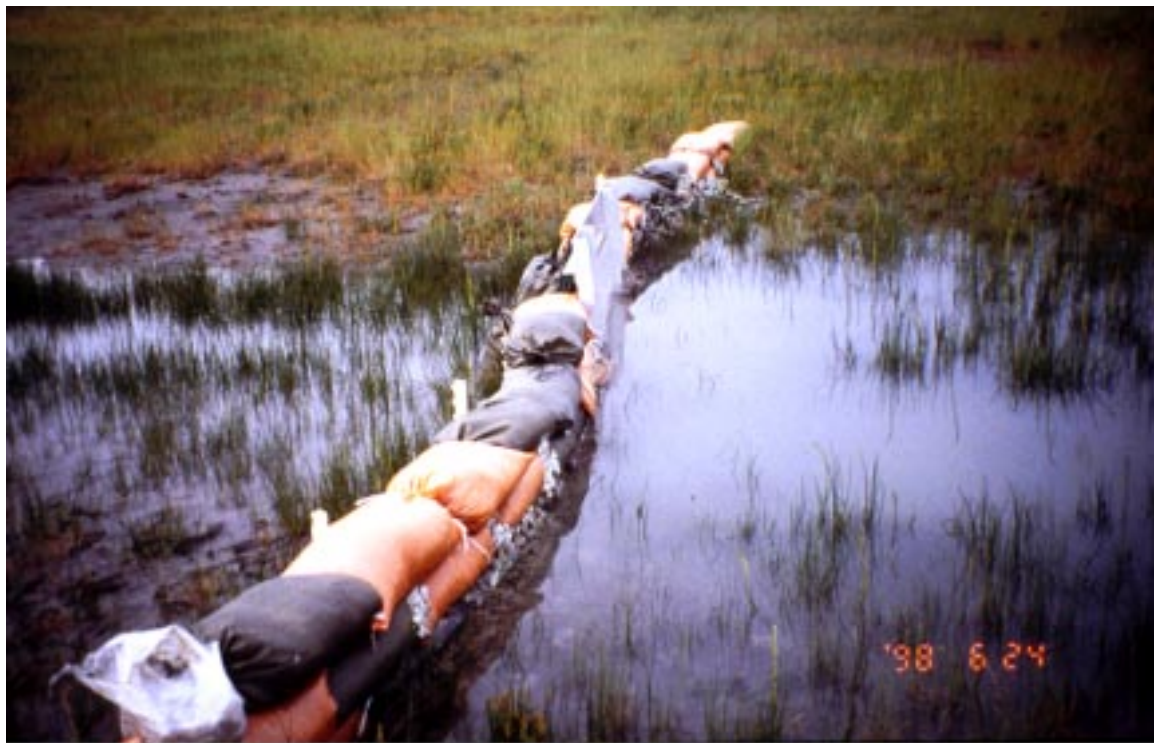
Figure III-1-3. Tide gate in B-Gully, Pond 183, during flooding tide.

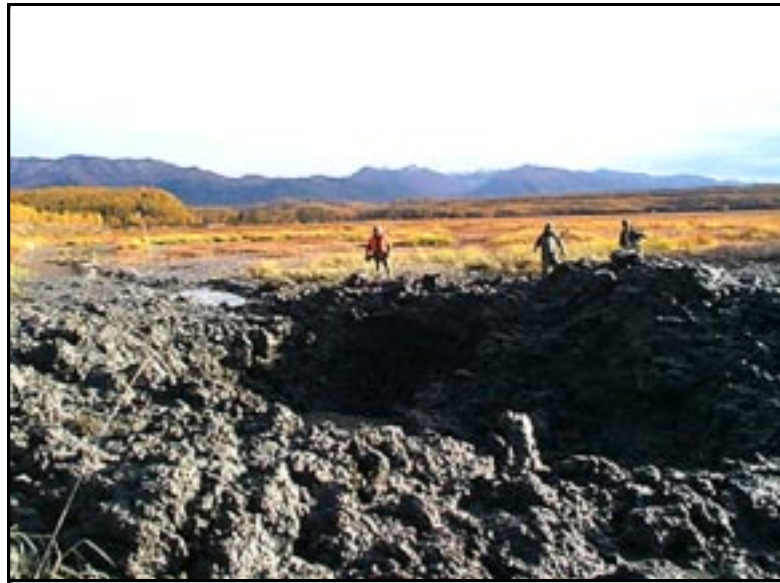
Figure III-1-5. Deepened sump in Pond 146, September 1999.

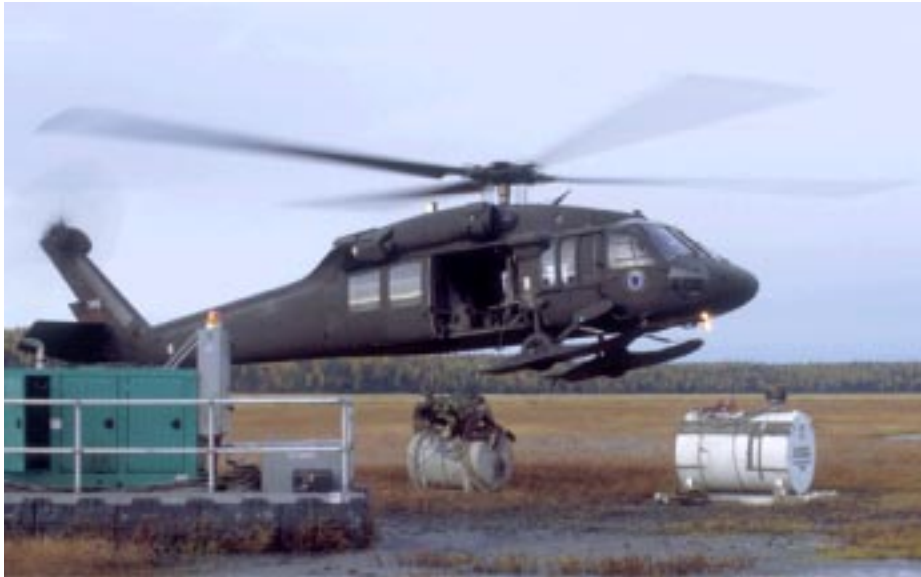
Figure III-1-8. Airlifting new 1100-L fuel tank. A 1900-L tank is to right.

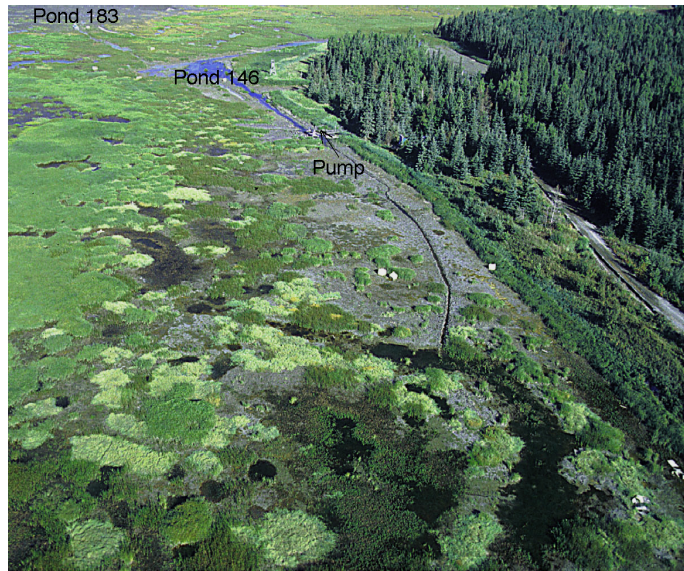
Figure III-2-5. View of Pond 146. a. Looking north toward Clunie Point.

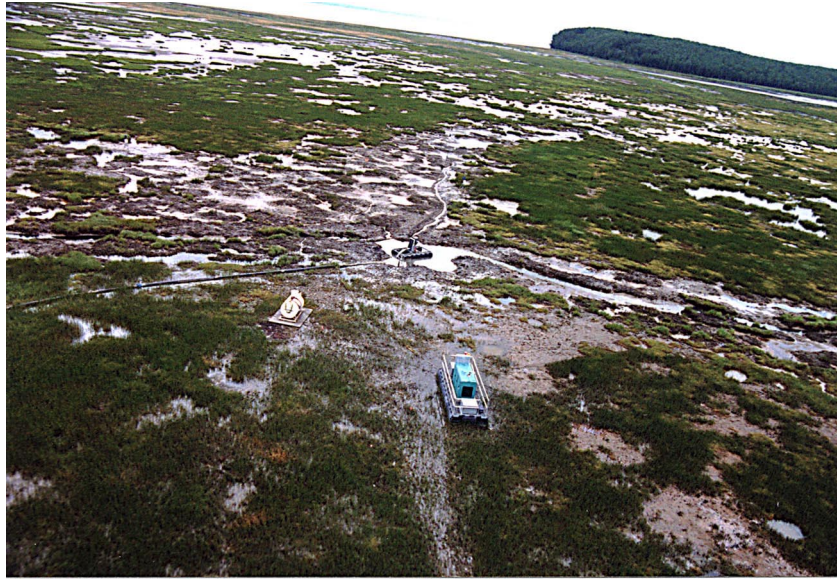
*Figure III-2-8. Pond 730 (looking north) after draining.*

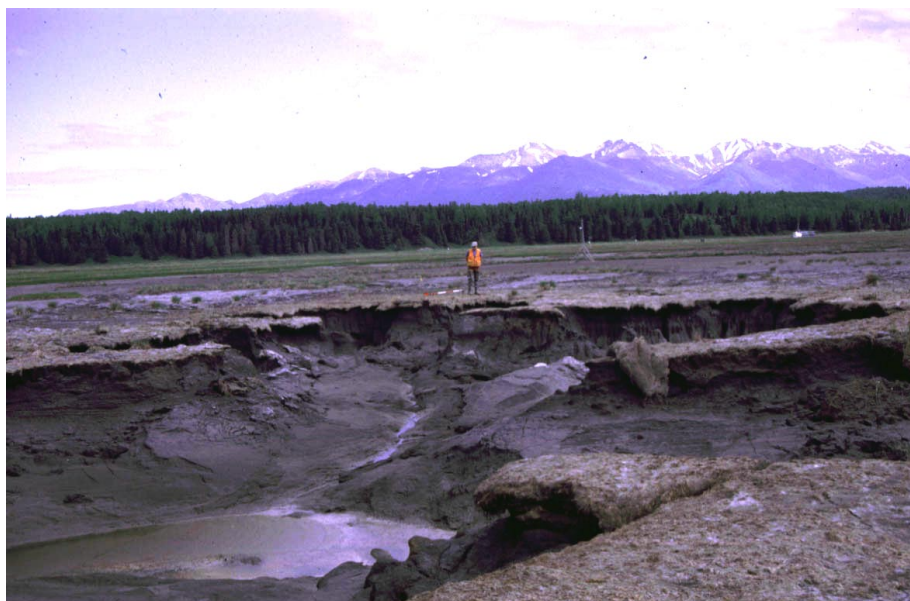
*Figure III-2-11. View of eroding Bread Truck Gully. Ronald Bailey is looking down on an exposed white phosphorus mortar round.*

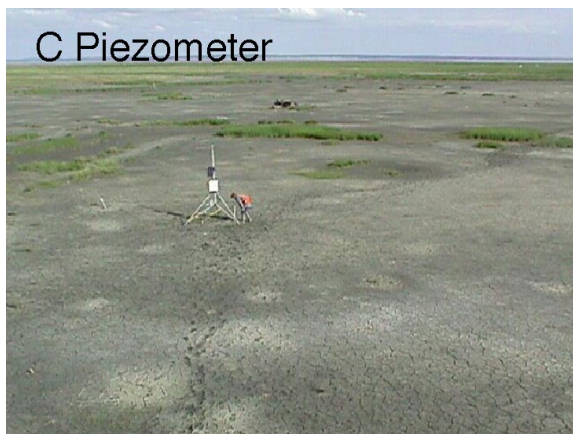
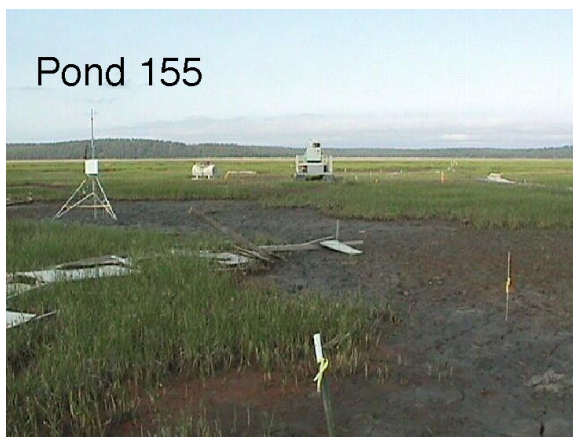
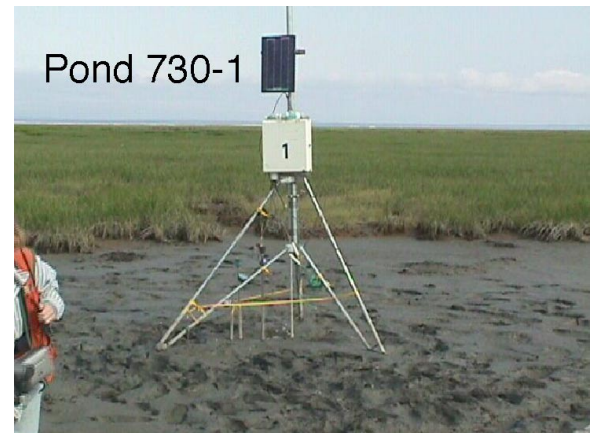
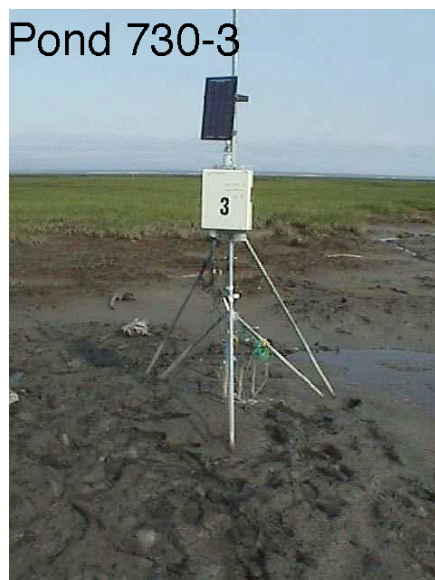
Figure III-2-13. Datalogger stations photographed on 7 July 1999 during a period of ideal drying conditions. (Photographs courtesy of Terry Edwards, Weldin Construction.)

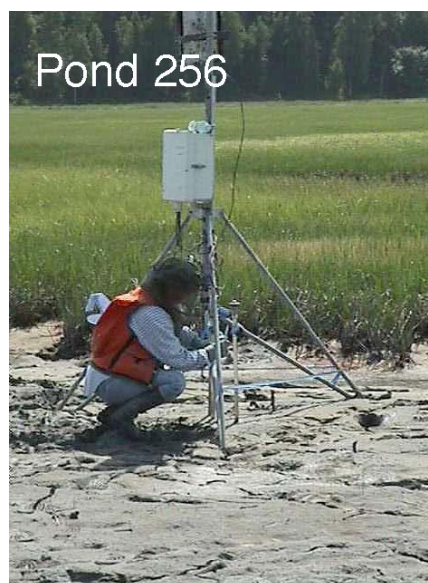
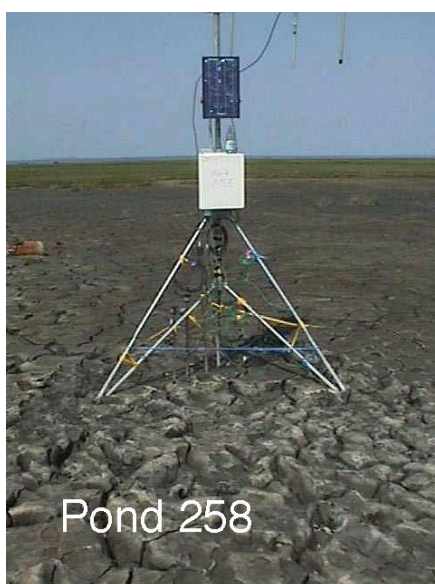
Figure III-2-13 (cont'd). Datalogger stations photographed on 7 July 1999 during a period of ideal drying conditions. (Photographs curtesy of Terry Edwards, Weldin Construction.)

This pond experienced frequent flooding from the Bread Truck ditch that constantly rewetted the drying sediments (Fig. III-2-14). Some drying did occur as the sediment consolidated and cracked (Fig. III-2-13). Loss of white phosphorus from the planted particles was 52, 62, and 21%. We did not detect white phosphorus in the 10 grid composite samples collected from this pond.

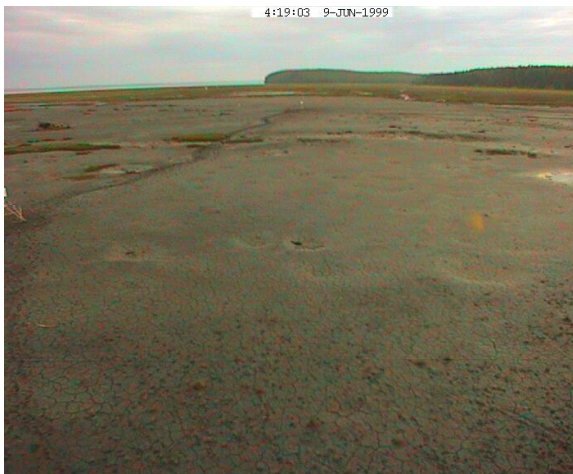
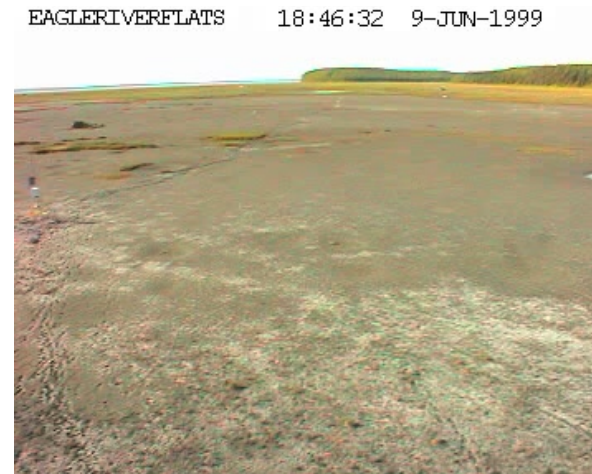
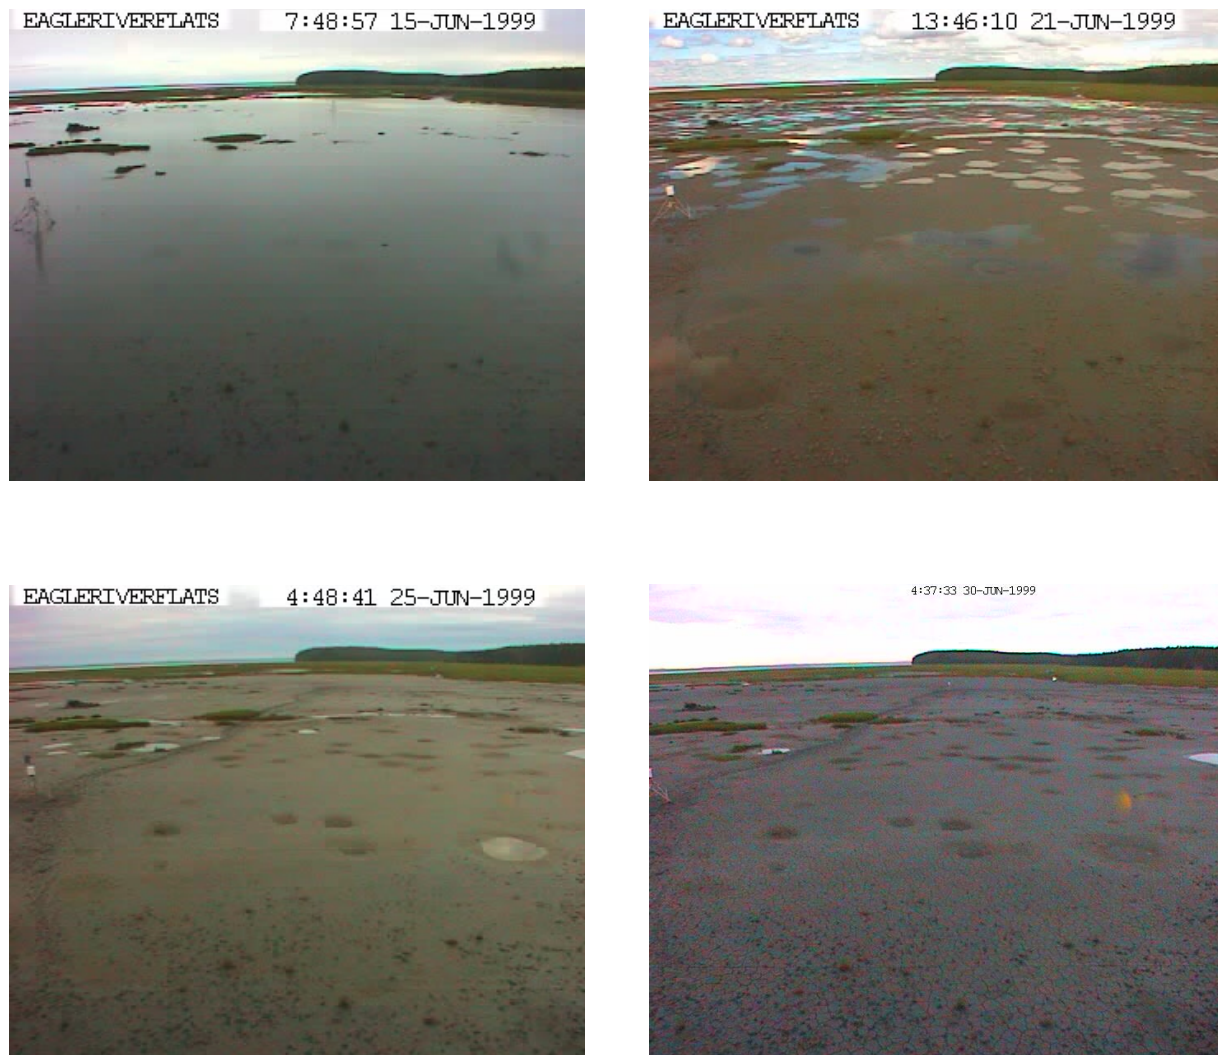
Figure III-2-15. Pictures from web cam showing flooding of Pond 183 in June 1999. Salt crust visible on 9 June is an indication of drying sediments. Sensors showed that the sediments were again unsaturated by 27 June.

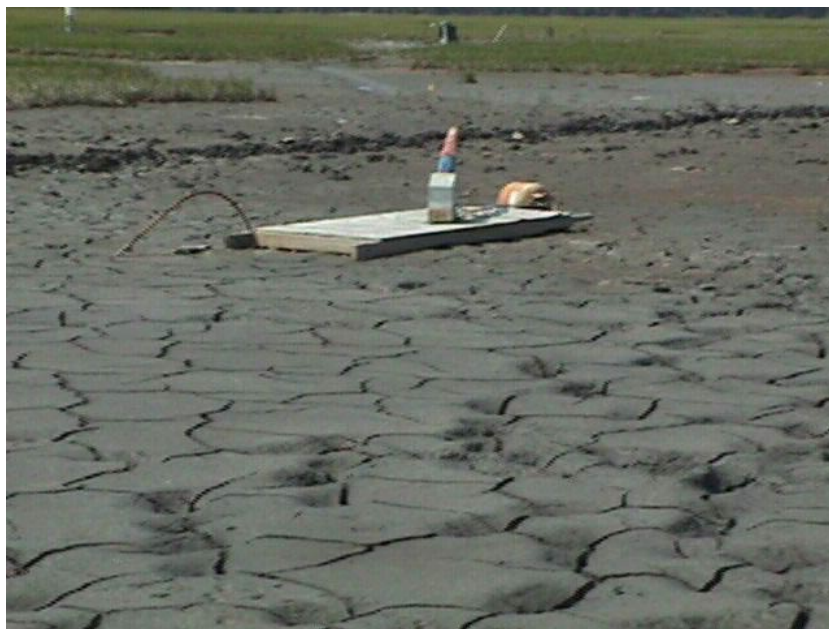
*Figure III-2-18. Ground view of Pond 258 in early July 1999. (Photo courtesy of Terry Edwards, Weldin Construction.)*

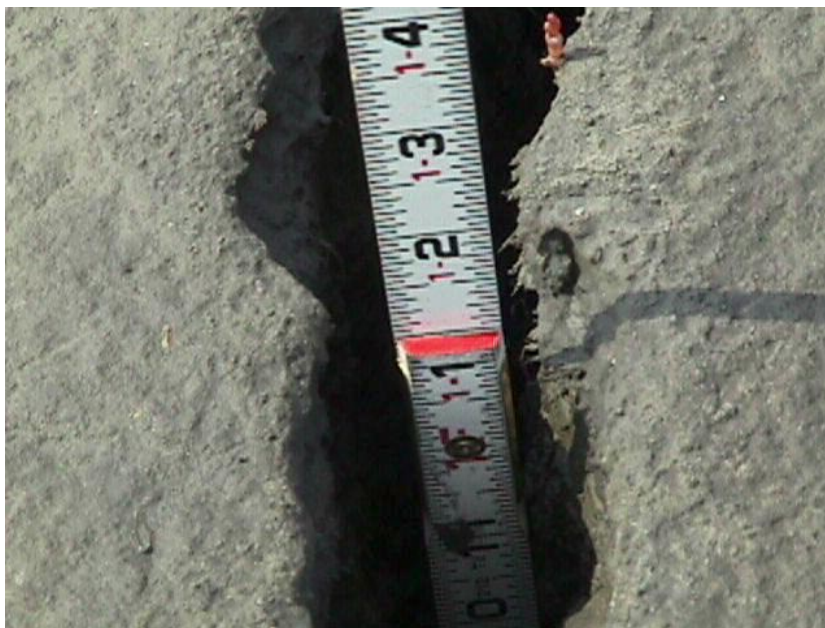
Figure III-2-19. Desiccation cracks in Pond 258 in early July 1999. (Photo courtesy of Terry Edwards, Weldin Construction.)

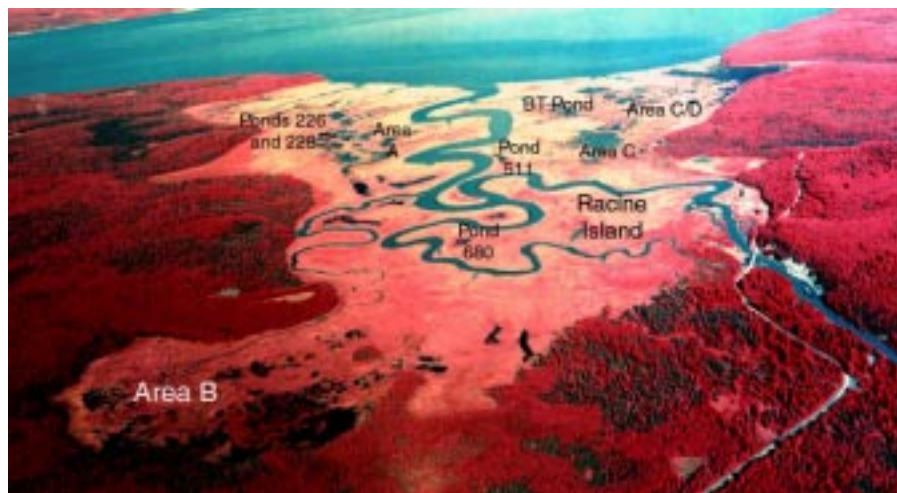
Figure III-3-1. Aerial oblique color-infrared photo looking N of Eagle River Flats, 17 August 1999.

The significance of Areas A and C/D (Fig. III-3-1, III-3-2) as sources of waterfowl poisoning is less clear. White phosphorus has been detected in the permanent ponds of both areas, but concentrations and detection frequencies have been low. Both areas contain extensive bulrush marsh that makes each area very attractive to waterfowl. The clues that led us to hot spots in Area C, the Bread Truck Pond, and Racine Island are absent in Areas A and C/D. In Area A, crater density is highest on

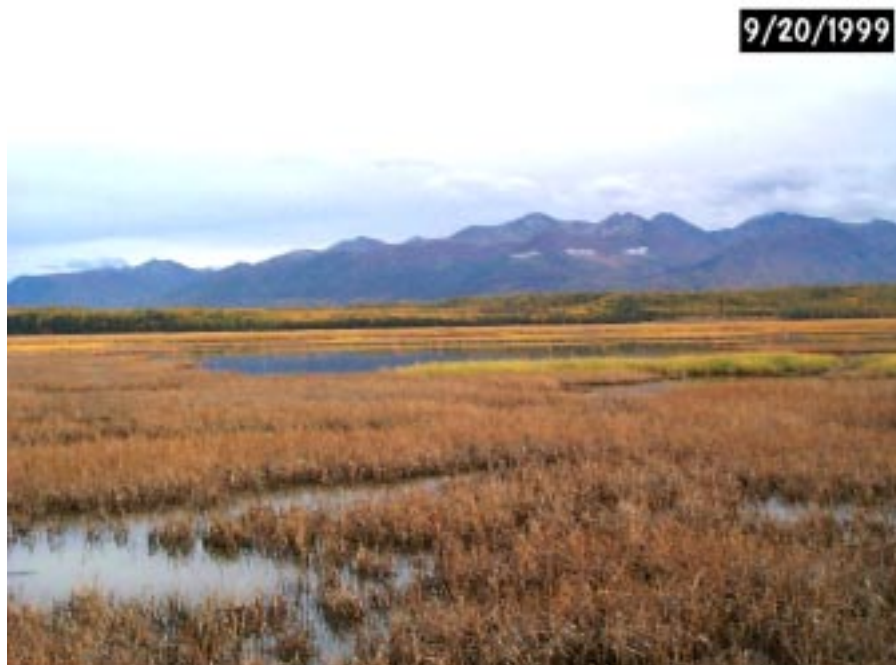
Figure III-3-2. Looking across to Pond 226 from west showing pond marsh complex in Northern Area A.

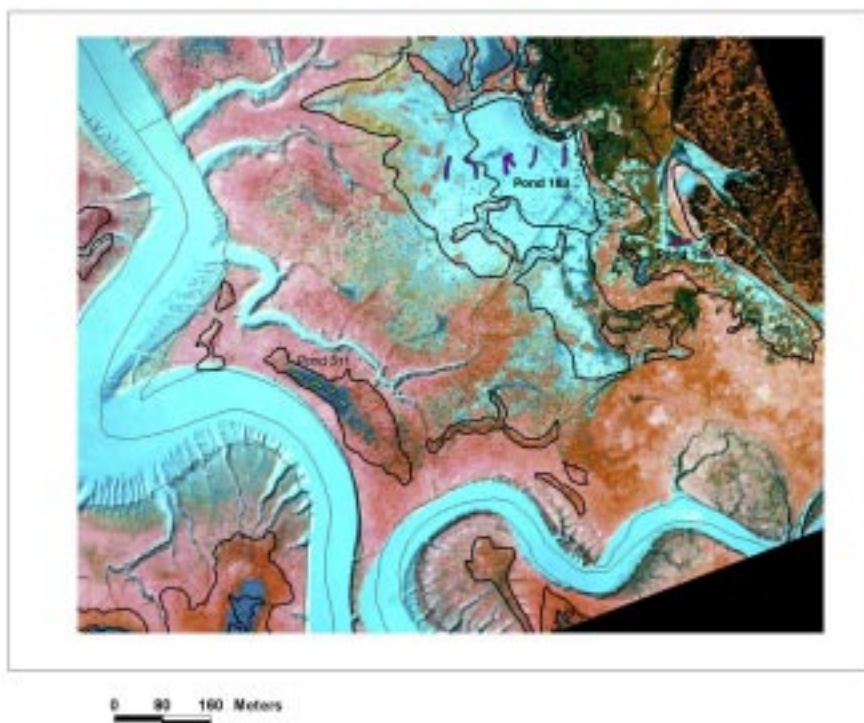
Figure III-3-4. Aerial color-infrared photo of Area C, showing locations of composite samples 1997 to 1999.

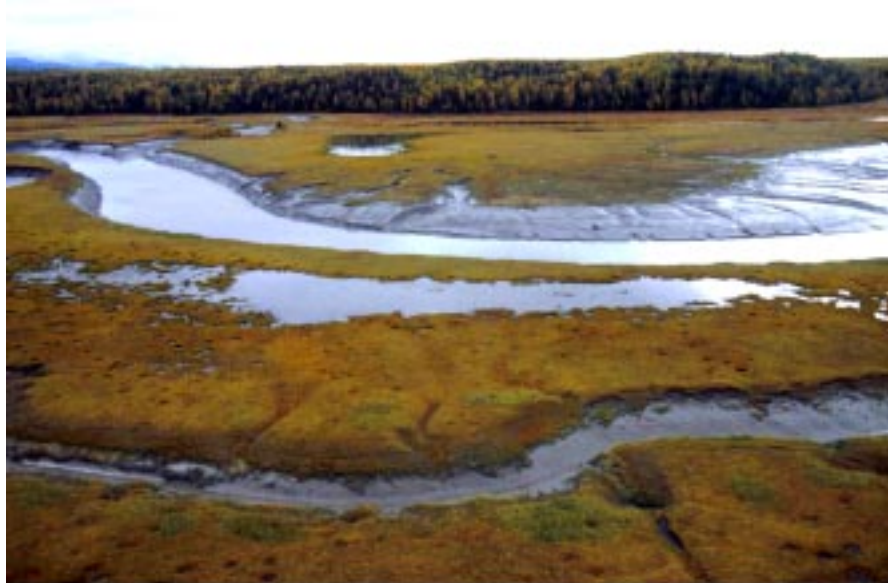
Figure III-3-5. Aerial oblique view of Pond 511 looking west. B-Gully is in the foreground, roughly paralleling Pond 511 and the Eagle River. Area A is in the background.

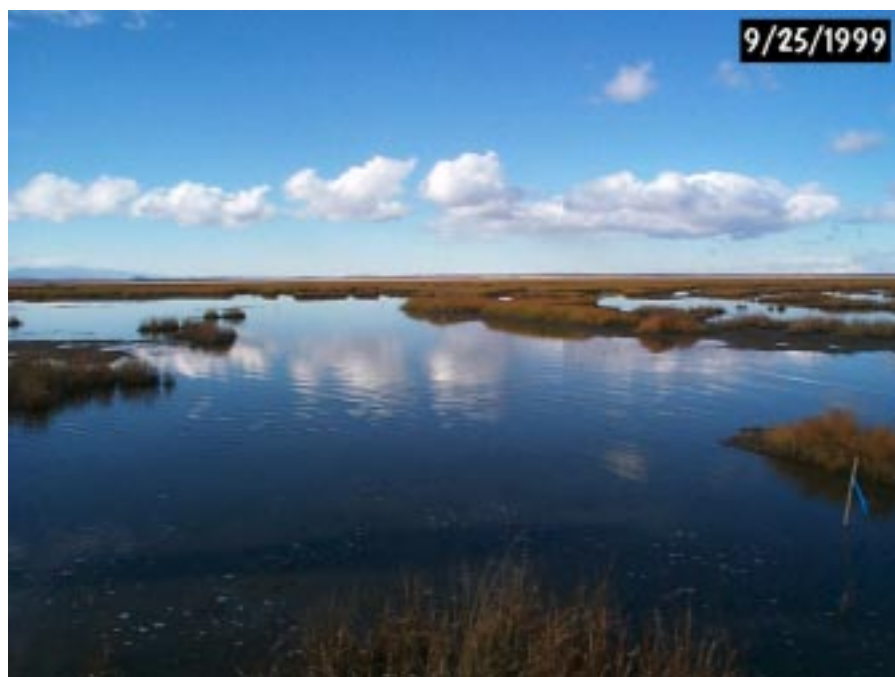
Figure III-3-8. Ground view of Pond 75, from which a positive ( $0.03 \mu\text{g/g}$ ) composite sample was collected in Area C/D–Coastal East.

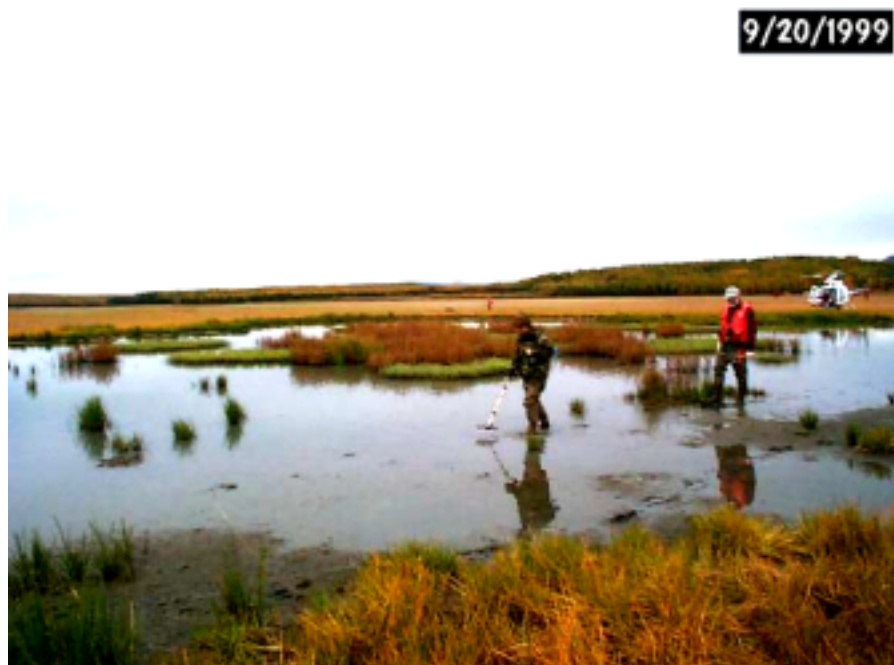
Figure III-3-9. Ground view of Pond 680 on Racine Island with Sherri Butters clearing of ordnance.

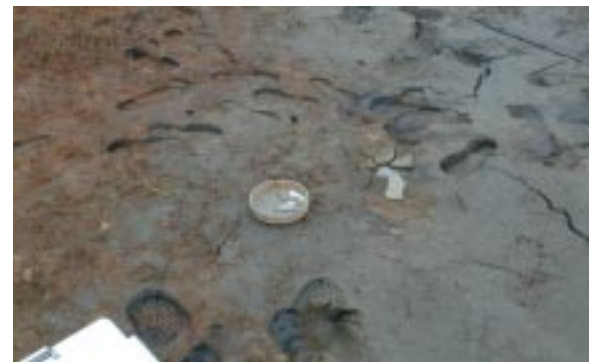
Line 11-13 1999

Figure IV-1-4. Comparison of a 1992 plot and the same plot in 1999. Loss of submerged aquatic species is almost immediate following pond drainage.

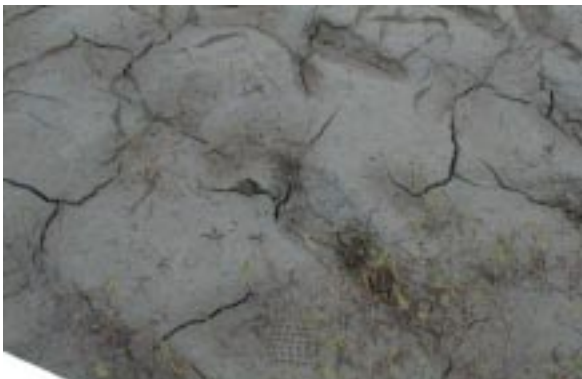
Line 11-12 1992

Figure IV-1-5. Loss of *Hippurus tetraphylla* vegetation from 1992 to 1999 in a 1- × 1-m quadrat placed in a pond drained by summer pumping in 1997, 1998, and 1999.

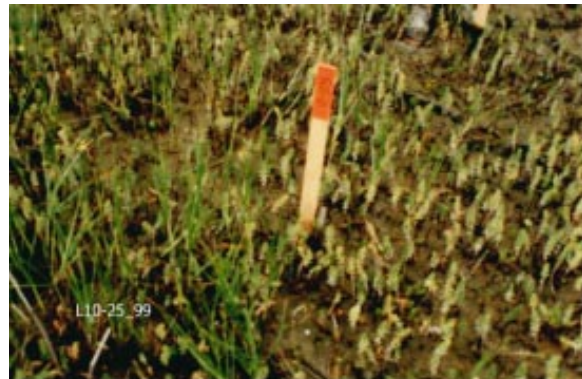
Line 10-25 1999

Figure IV-1-6. Persistence of *Hippurus tetraphylla* in a poor condition in the Bread Truck Pond, which was ditched rather than pumped and, therefore, floods during occasional high tides.

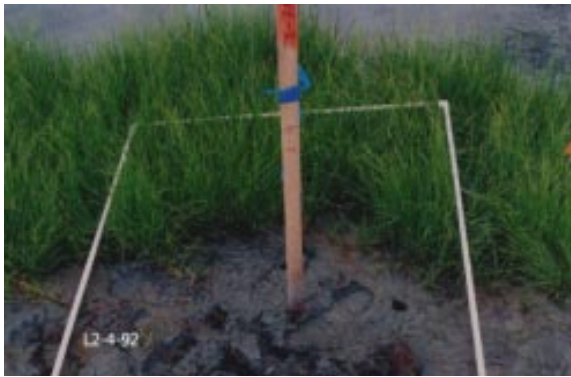
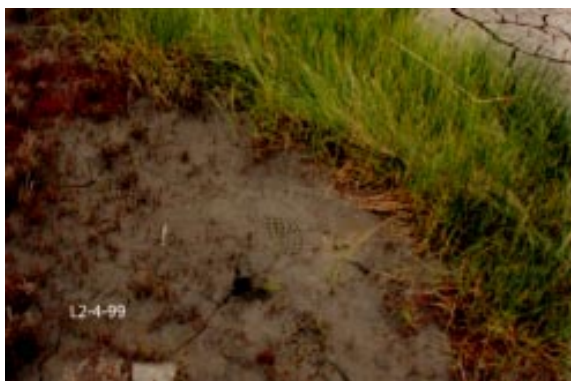
*Figure IV-1-7. Plots in ponds with Carex Ramenskii, showing persistence of this species after 4 years of pumping.*

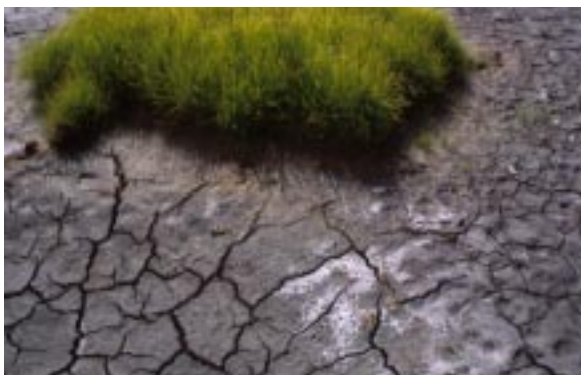
*Figure IV-1-8. Ramenskii's sedge persists in an intermittent pond that has dried and cracked.*

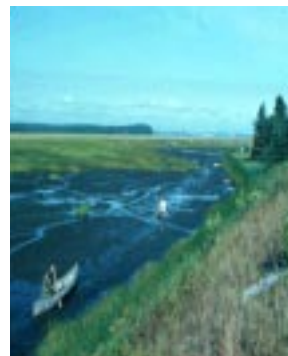
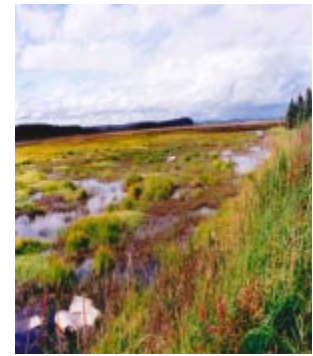
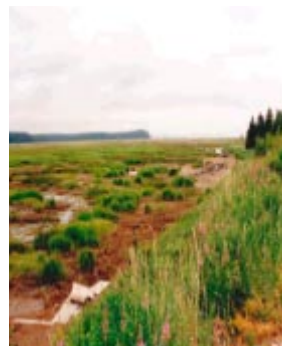
*Figure IV-1-9. Photos of Pond 146 before pumping during 1998 and 1999 and in August 1999, showing expansion of sedges.*

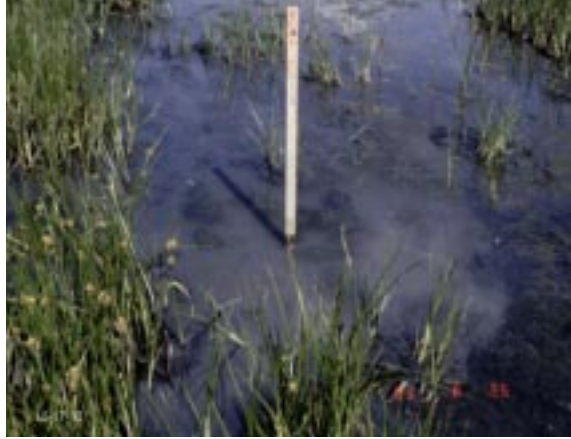
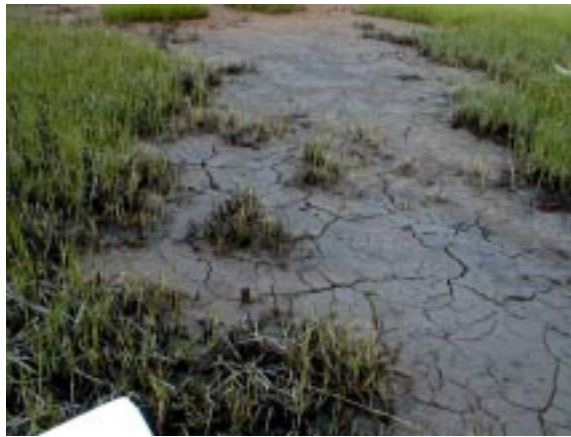
Figure IV-1-10. Photos of a plot in 1992 and 1999 of bulrush following only one summer of pond pumping between Ponds 146 and 183. Little change in bulrush vegetation is apparent here.

It is difficult to detect changes in the almost mono-specific large areas of bulrush (*Scirpus paludosus*) marsh bordering the inner side of the Bread Truck and C Ponds. The few plots established in 1992 in this zone did not show major change (Fig. IV-1-10). Surviving vegetation in Pond 730, pumped for the first time in spring 1999, suggests that the tall green bulrush (*Scirpus validus*) was able to resprout by late August, but it has been greatly reduced in abundance.
